# Towards an improved wind speed scale and damage description adapted for Central Europe

Bernold Feuerstein, Pieter Groenemeijer, Erik Dirksen,  
Martin Hubrig, Alois M. Holzer, Thilo Kühne, Nikolai Dotzek†

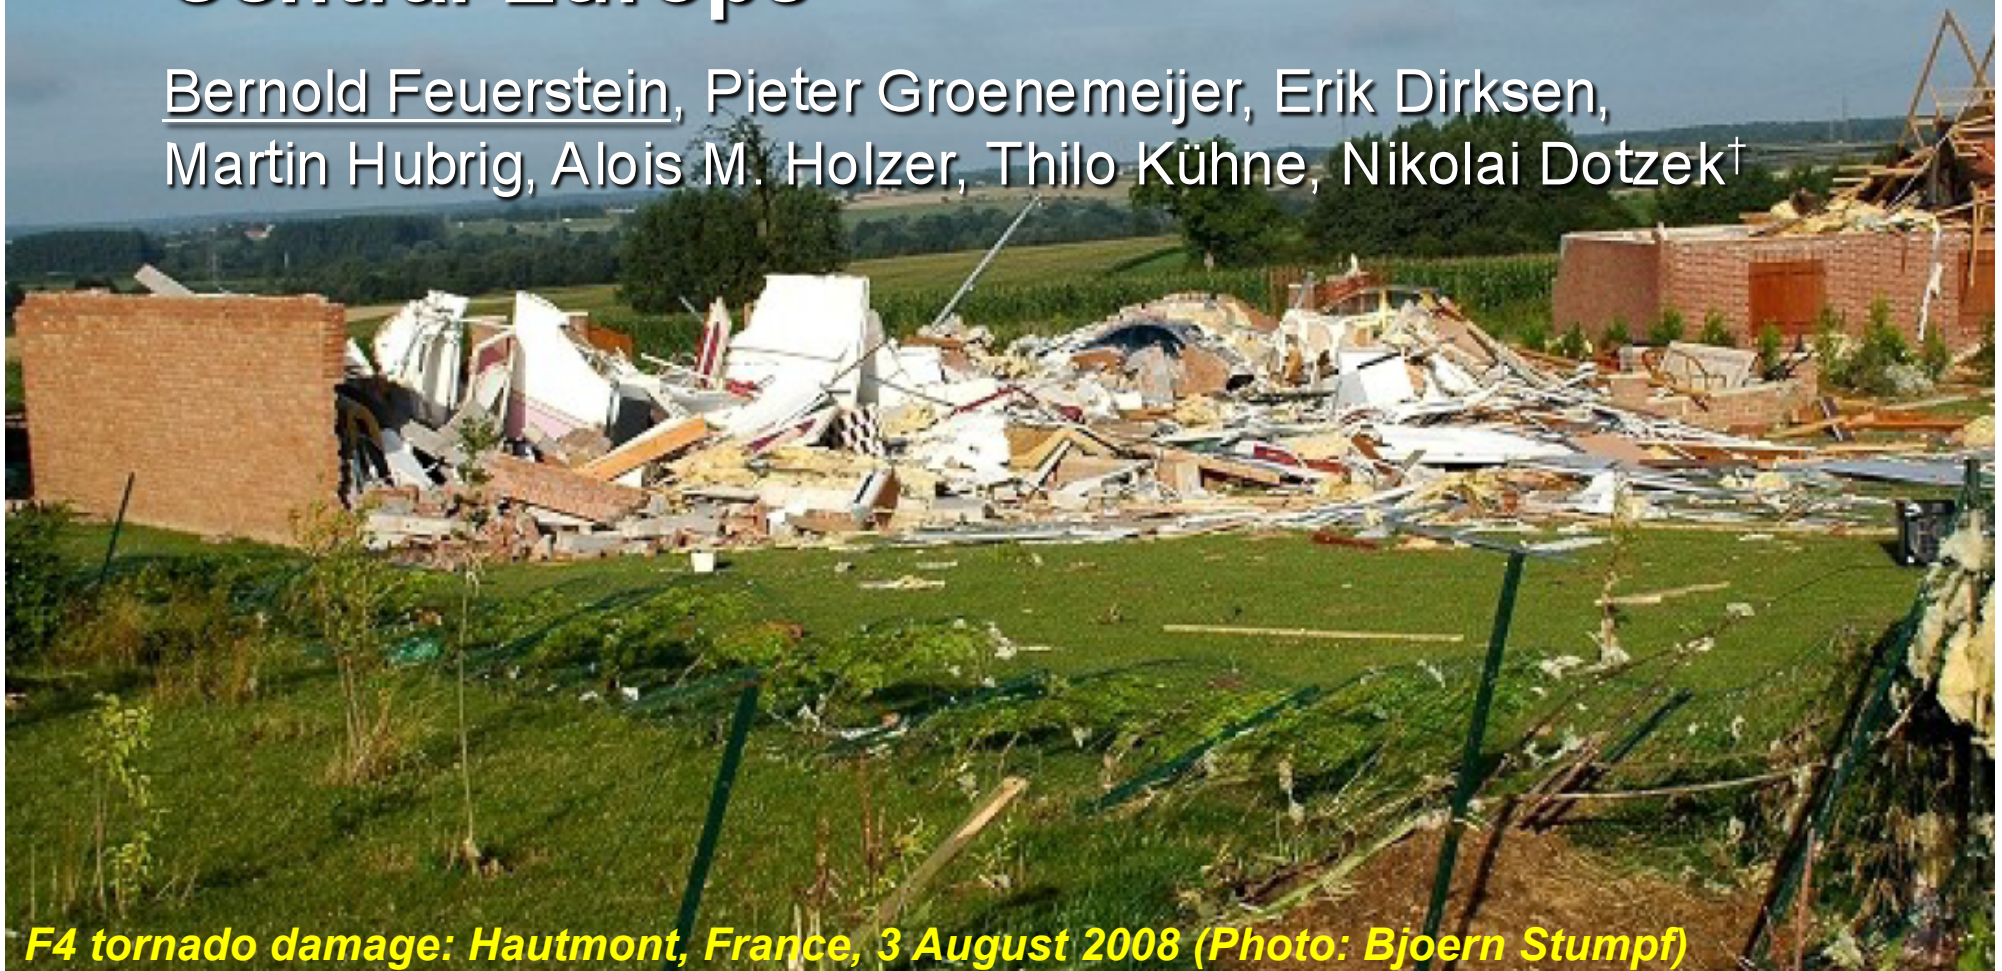
***F4 tornado damage: Hautmont, France, 3 August 2008 (Photo: Bjoern Stumpf)***

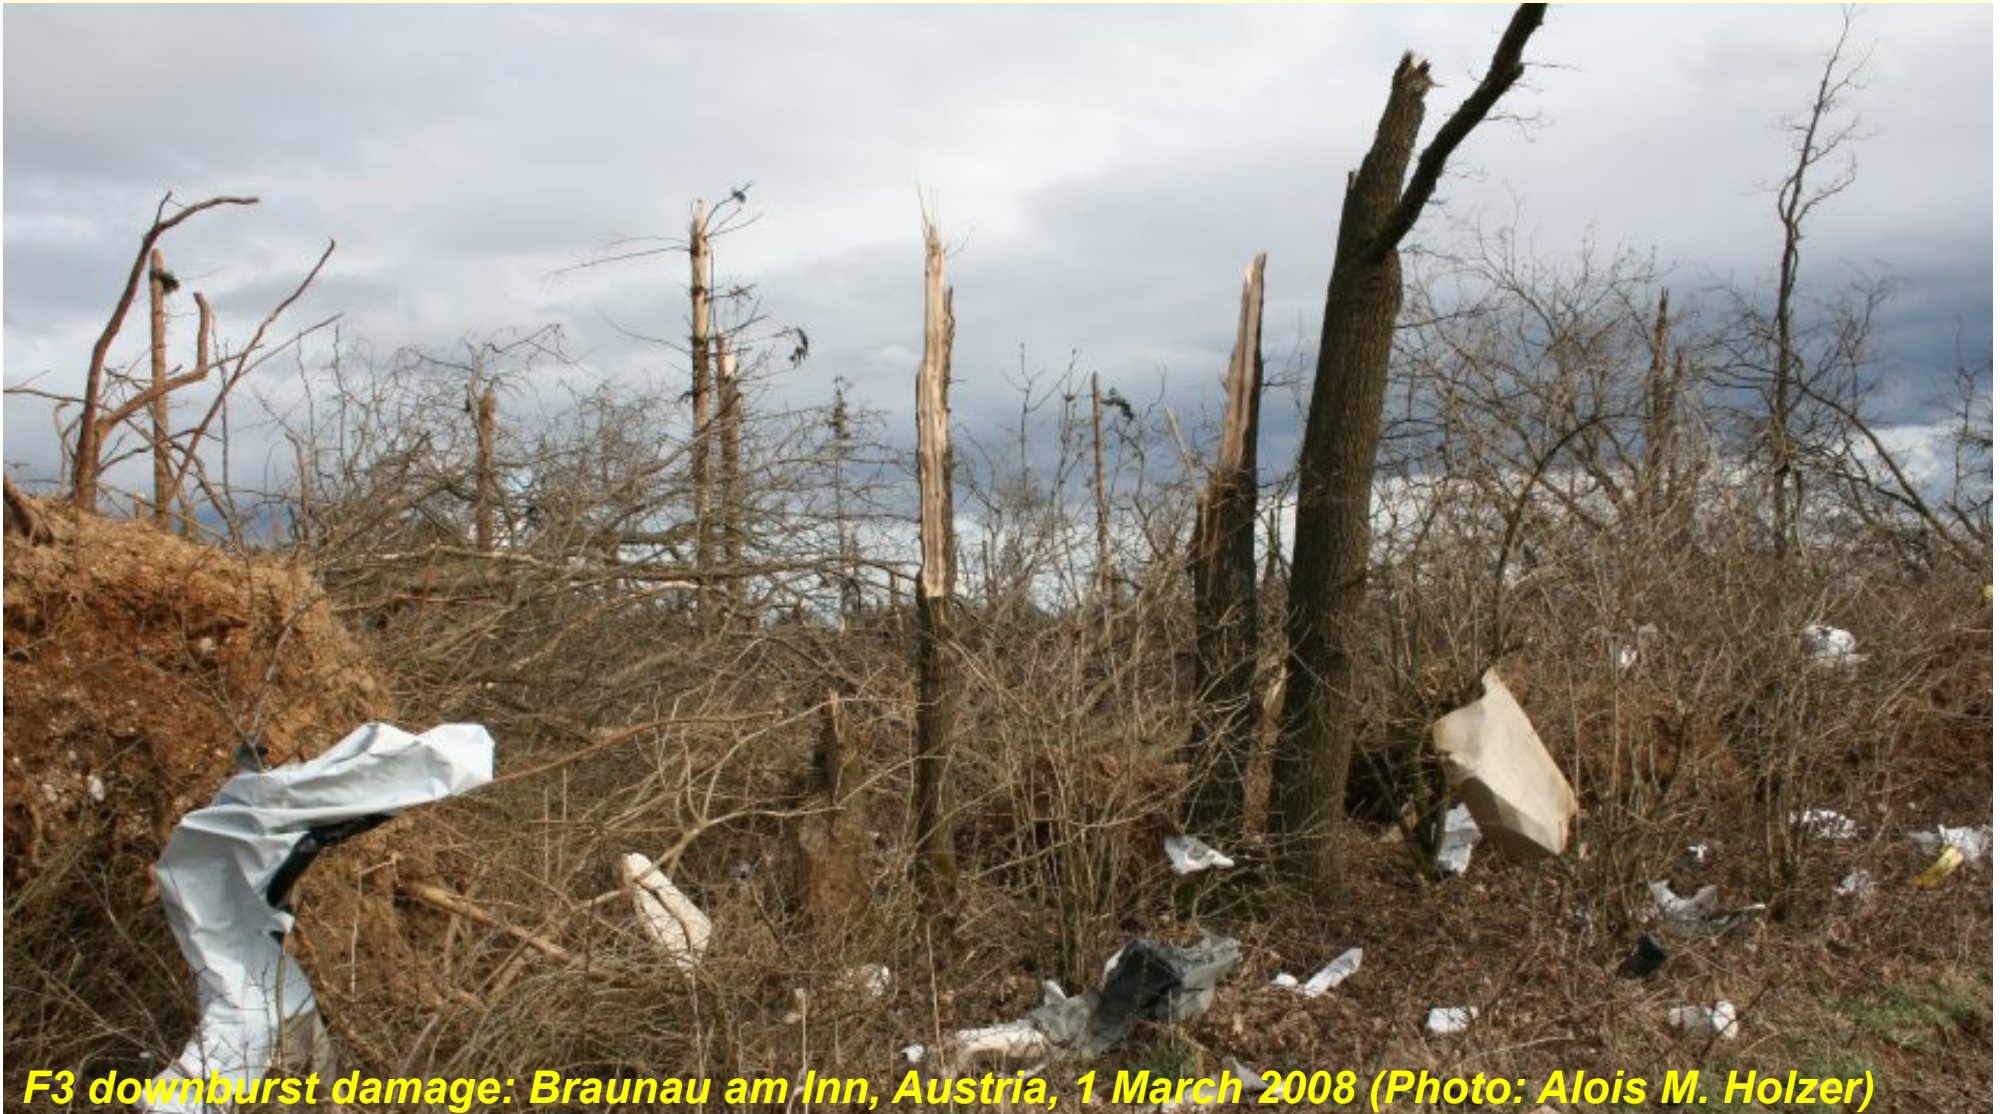
***F3 downburst damage: Braunau am Inn, Austria, 1 March 2008 (Photo: Alois M. Holzer)***
